LIMITED ASBESTOS BUILDING INSPECTION

1159 Willow Bend Cir #B
Colorado Springs, CO 80918

April 20, 2015

April 27, 2015

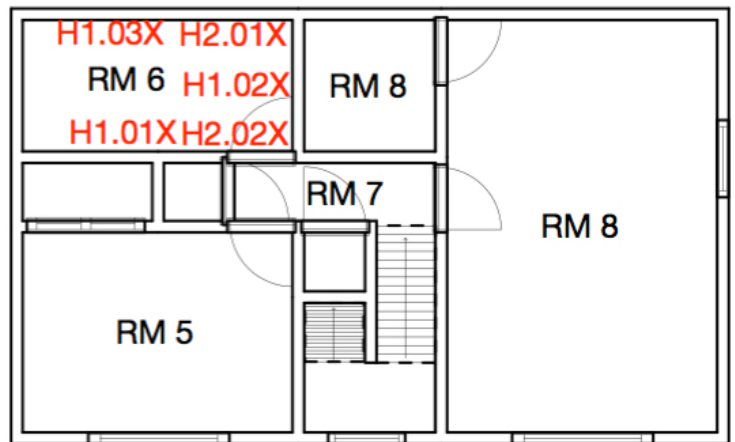
SECOND FLOOR

Bulk sampling conducted during this inspection identified that the wall and ceiling texture in the second floor bathroom of the property contains asbestos (3% Chrysotile).

Assessment: This inspection identified the material as undamaged and friable at the time of the inspection and had a hazard assessment of “Asbestos Containing Building Material (ACBM) with high potential for damage”. This assessment was assigned to the material because of the planned renovation taking place and the close proximity to workers and or occupants. There is approximately 300 square feet of wall and ceiling texture in the second floor bathroom of the property.

Bulk sampling conducted during this inspection identified that the joint compound in the second floor bathroom of the property contains asbestos (2-3% Chrysotile).

Assessment: This inspection identified the material as undamaged and friable at the time of the inspection and had a hazard assessment of “Asbestos Containing Building Material (ACBM) with high potential for damage”. This assessment was assigned to the material because of the planned renovation taking place and the close proximity to workers and or occupants. There is an unknown amount of joint compound in the second floor bathroom of the property. This material was composited and is below the EPA and State of Colorado regulated limit of 1%, however, OSHA guidelines and regulations still apply to this material.

Please Note: CES recommends all renovation work impacting ACM in the building be completed by an EPA certified and Colorado State licensed General Abatement

Contractor (GAC).
